## Two Tales of Recent Maintenance Issues

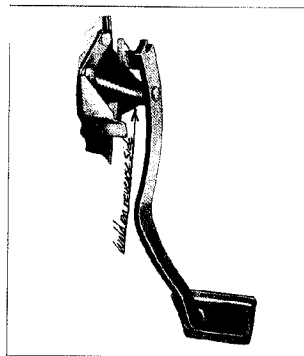
Fig. 6B-1—Clutch Linkage

1. One of our members, Linda Reece, was driving in Harrisonville with her grandchildren tucked into her 1964 Spyder convertible when the clutch pedal went to the floor and then the entire pedal and arm assembly fell out onto the floor. After driving without a clutch to a safe spot, she called me with the errant part in her hand. After I explained what had happened she contacted friends and a tow truck and had the Spyder brought to my place. This particular trauma is only common to manual transmission early model cars but it is a combination of marginal welding at the factory, cycles of use and stiffness of the pressure plate and return spring. The support that is bolted under the dash has a tube welded to it that has two plastic bushings for the clutch pedal to pivot on. If you have an early model car with manual transmission I would recommend heading off the possible failure by initiating a preventive operation.

At first examination it looks like you cannot remove the assembly without taking out the steering column but with a little twisting of the support you can accomplish removal and installation. The first step is to remove the clutch return spring and unhook the adjusting rod from the lever in the rear so you have slack in the cable. Next, since there are plastic bushings at the welding site, you must unbolt the assembly (3 bolts), remove it with the pedal stop and then remove the snap ring and two bushings. If the tube with the bushings has already bent slightly, be sure and use a square to align it before welding. Hook the clutch cable clevis back on the pedal arm before bolting the bracket tight.
