### Loss of Transmission Fluid at the Vent on the Powerglide Transmission

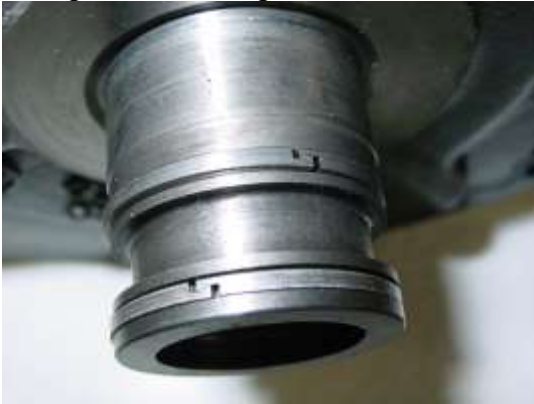
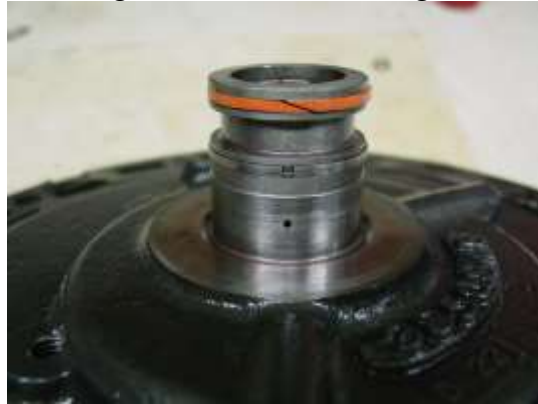
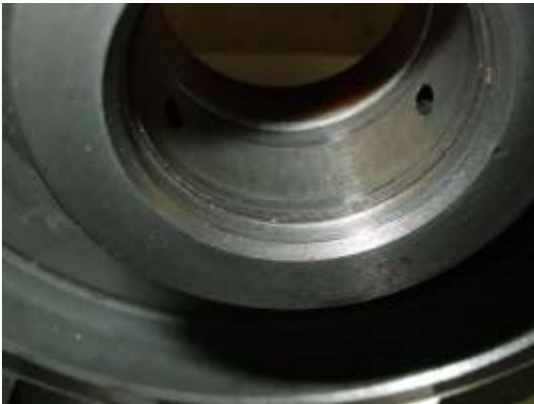
If you have a fluid loss from the vent, I would try a **complete** change over to synthetic fluid first since it boils at a lot higher temperature than standard ATF. Original ATF may actually boil at lower temperatures than you would think due to a change in viscosity and loss of additives after 50 years. You will need to drain the converter, pull the pan, and pull the pickup in order to get the maximum amount of fluid out of the transmission. If changing fluid does not solve the problem, then perhaps the above information will be useful. Pictured nearby is the drum sealing area and the pump hub with its two rings. Also pictured is the plastic substitute that was residing in the Moore's Powerglide.

**And finally:** this spring one of my Powerglide Corvairs started spitting out some fluid on a 150 mile trip on the highway. The transmission was original with 130K and perfect Amsoil fluid, and I was absolutely sure it was not getting hot having checked it with an infrared heat gun. For repairs, I left the transaxle attached to the engine and only removed the front pump cover, front pump and clutch drum for inspection. The inside of the clutch drum had two grooves worn into the mating area and if you inserted the steel butt-end ring into the groove you could see the gap expand. I also could catch my fingernail in the grooves. Unfortunately, there is no good solution that I have for repair other than another good used drum. I did replace both rings with new ones from Clarks (sure glad they are there!) and I checked the two bushings involved (clutch drum and front pump) as well as the bushing area on the front pump shaft and the bushing area on the front pump hub since those could affect the loading on the sealing area if there was excessive clearance. The new rings from Clark's are butt joint and originals I have found could be either butt joint or interlocking. Other than the sealing ring areas I found no other indication of excessive wear on any of the parts I had removed in this limited operation. Ideally I should have gone completely through the transmission while it was accessible but I wanted to confirm once and for all that the sealing ring area could cause the fluid loss through the vent.
