The Preventive Maintenance Series

Viton Crankshaft Seals: I recently had to pull the engine and replace the flywheel end crankshaft seal on my Lakewood which only had 10,000 miles on the seal since installation. This is the fourth leaking Viton crankshaft seal I have replaced in various vehicles in the past few years; two seals I had installed and two had been installed by others. None of them should have had to be replaced; I have a Clark's Polyacrylate crankshaft seal in one of my Greenbriers that has been there since 1985, and still dry.

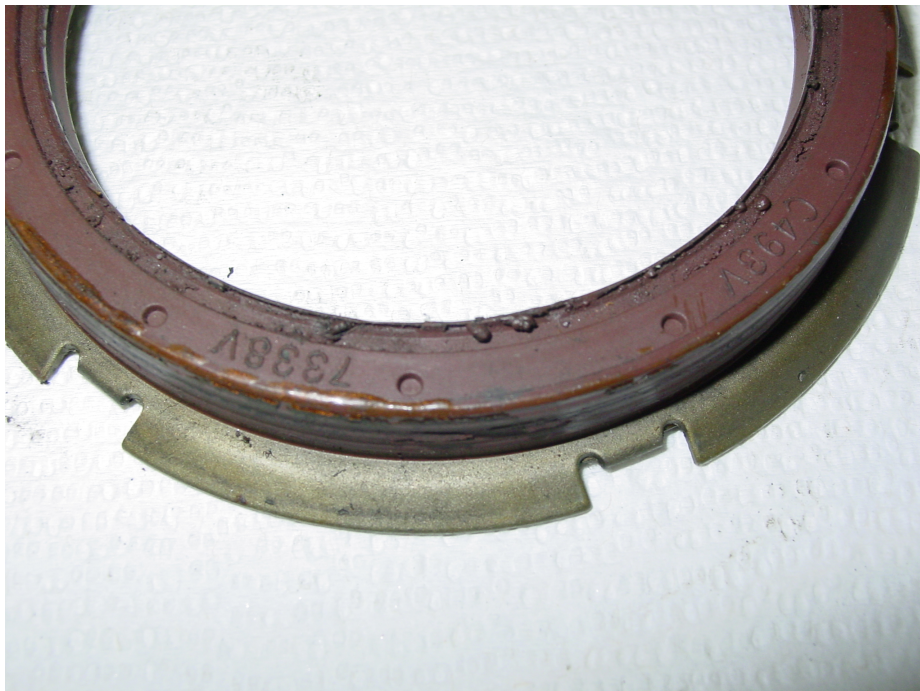
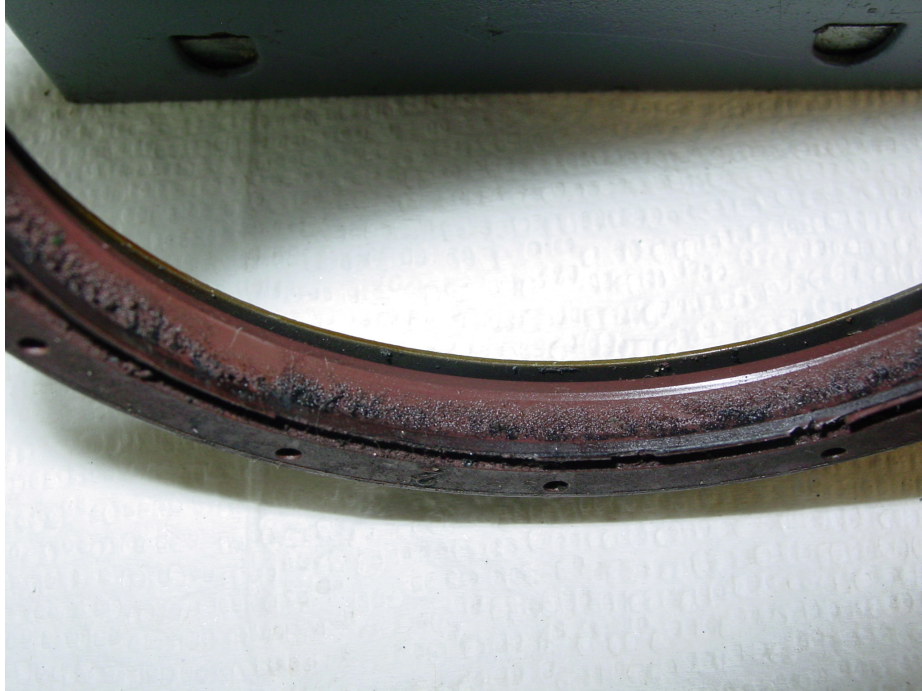
Looking at the pictures you can see that the primary lip (bottom picture) has a worn and flatten appearance (shiny area) and you can see evidence of grease residue. The secondary lip had crumbled and began peeling from what was obviously overheating caused by a lack of lubrication. Even the grease placed between the lips is not enough for the years and mileage if the primary lip does not allow oil seepage for lubrication purposes. I guess I am thinking that the Viton does too good a job (Viton tube seals last forever) and is not well suited to a rotational assignment.
