THE PREVENTIVE MAINTENANCE SERIES

Corvair Engine Cooling Fan Bearings

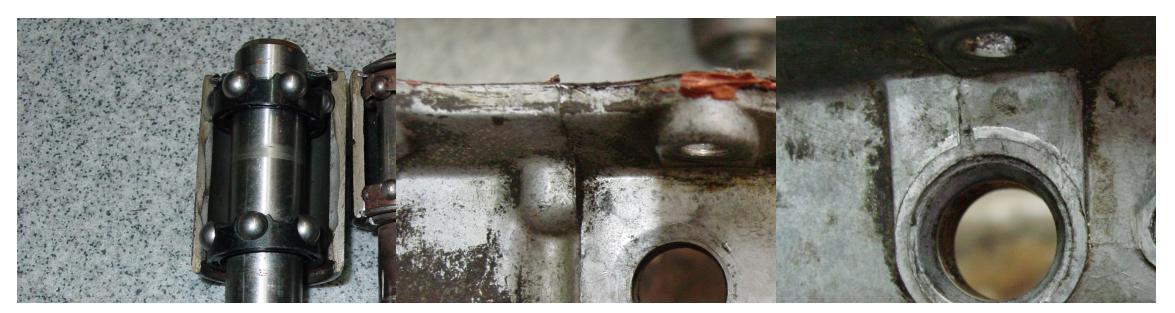
Pictured nearby are comparisons of the two bearings and the two top cover PCV tube mounting areas. The PCV tube must be mounted tight and sealed properly or you will have blow-by gases in your heater.

History: There were two basic types of engine cooling fan bearings; the smaller bearing (and smaller mounting shaft) was used from 60-64 and the larger bearing (and larger mounting shaft) was used from 65-69. The top covers have to match the two bearing shaft diameters and the fans and pulleys have to match the bearing flange mounting diameter and bolt size. The early bearing & hub combo was changed once but retained the same diameters so any early bearing will fit any early hub or top cover. There were also different mounting areas on the top covers to accept the road draft tube or PCV tube. The tube and seal have to match the top cover. You can convert the early style fan bearing to the late style as long as you match up the proper parts. This would be a worthwhile upgrade since the late bearing has larger ball bearings and a larger race diameter. The baffles under the cover were also changed although they are interchangeable. The later baffle is supposed to be better (and stiffer) so consider that in an upgrade.
