THE PREVENTIVE MAINTENANCE SERIES

Motor Oil Leaks At The Clutch/Converter Housing Area

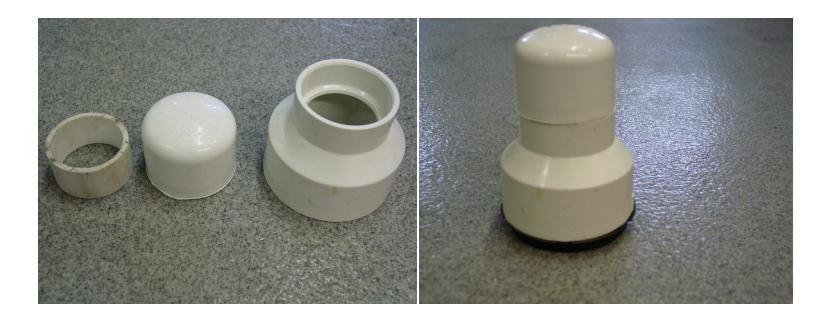
Crankshaft Seal Installation Tool

Pictured is an inexpensive tool for pressing in the seal. Constructed from PCV fittings purchased at the hardware store, you need the following: 3" x 2" reducer, 2" cap and a short piece of 2" pipe. The two fittings cost less than \$5 plus a short piece of pipe for assembly. You can use this tool in a press or use it carefully with a hammer, just be sure not to cock the seal if using a hammer.
