The Preventive Maintenance Series

Noland's Cylinder Head Service

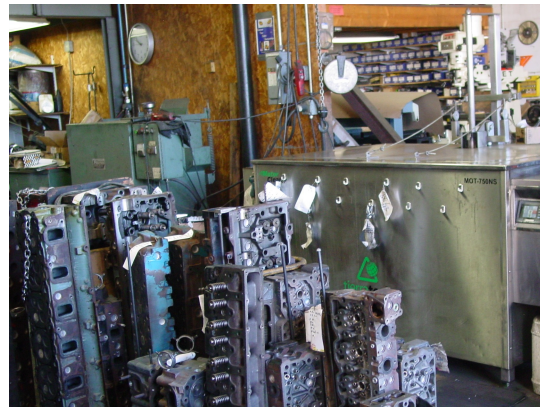
Ultra Sonic Cleaner in the Background
