Fuel Pump and Pertronix Ignition Tips

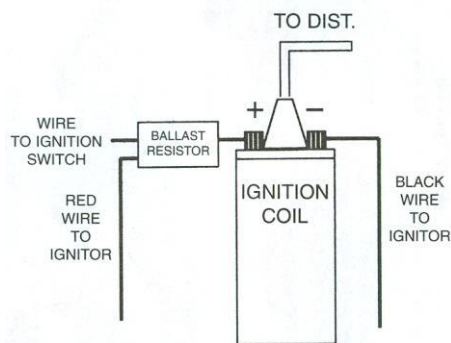
FIGURE 3
WIRING DIAGRAM
IGNITOR SYSTEM
WITH BALLAST RESISTOR

The issue is in wiring the Pertronix unit to the reduced voltage at the end of the resistance wire leading to the coil; this is the red wire from the distributor unit. The Pertronix requires full battery voltage to this red wire and if it is simply hooked to the + side of the coil it will not have battery voltage during run-time, it will be a reduced voltage (less than 6) and can cause running issues. Two recent problems I encountered included one Corvair that died while idling on my driveway and kept stalling until I re-wired the Pertronix to have a constant 12 volts. Another Corvair would miss-fire randomly and also would suddenly have a string of detonations that would come and go. It also was cured by wiring the Pertronix unit for 12 volts instead of the reduced 6 volts from the inline resistor that is the standard wiring for all Corvairs. Read instruction 25 that comes with

the Pertronix unit, it specifically states hooking the red wire to the ignition switch side of the resistance. Also note the nearby copy of the Pertronix furnished diagram of the wiring; it may be a little confusing but it does indicate the hookup should be **before** the resistor. This can be done on the front side of the multi-connector in the forward left side of the engine compartment. Pick the wire that feeds the only fabric covered wire exiting to the rear of the car from the connector. Make a T connection and hide the wire in your harness around to the Pertronix unit. The original wiring to the + side of the coil should be maintained.
